# NATIONAL TRANSPORTATION SAFETY BOARD

## TRANSPORTATION SAFETY RECOMMENDATIONS

ADOPTED DURING THE MONTH  
OF FEBRUARY, 1998

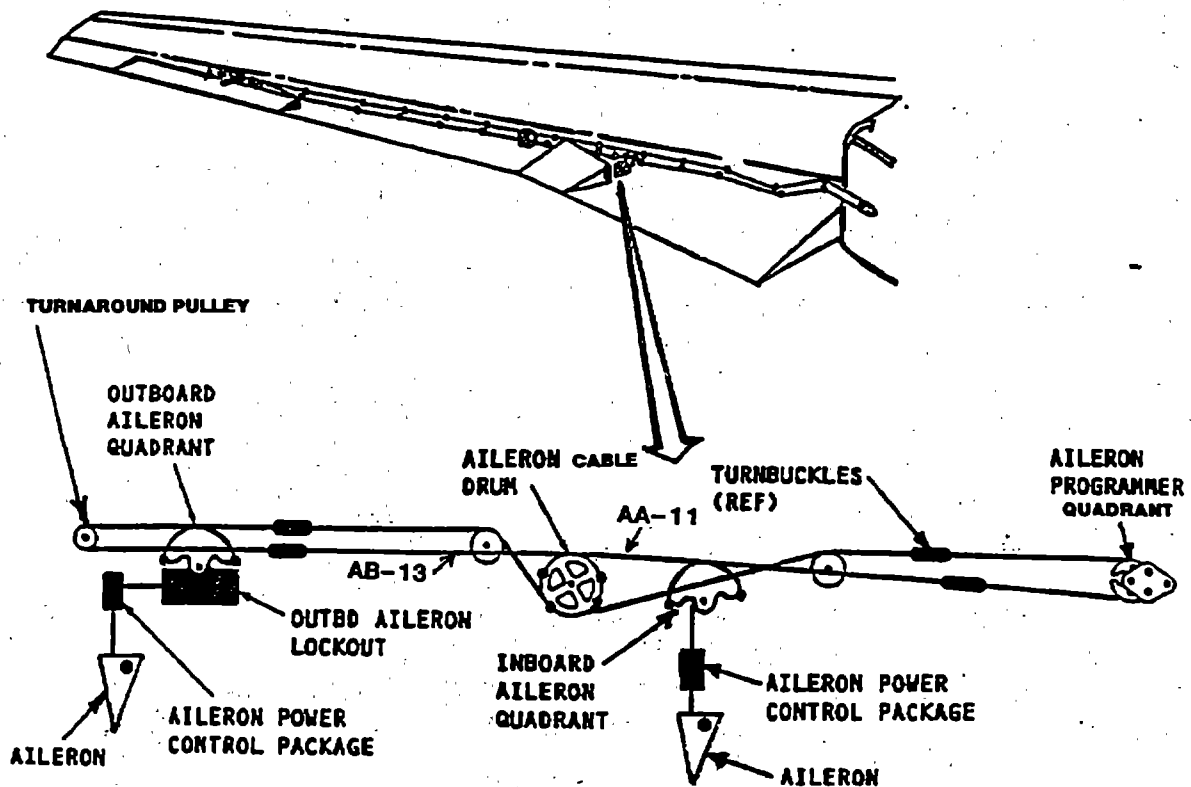
Figure 1. Aileron Wing Control Cable System.

Each wing has two AA and two AB aileron cable assemblies (see Figure 1.), one inboard and one outboard. The inboard AA cable run connects the aileron programmer quadrant to the aileron cable drum, and the inboard AB cable run connects the same quadrant to the inboard aileron PCU quadrant. The outboard AA cable run connects the aileron cable drum to the outboard aileron quadrant, and the outboard AB cable run connects the drum to the same quadrant via a turnaround pulley. The aileron cable drum, which is located at wing station (WS) 776.98, is a four-slotted pulley with a guide pin and is used to provide a complete (closed) cable loop to the inboard aileron even if the outboard segment is lost because of malfunction. The guide pin's purpose is to ensure that all four cables remain in the correct pulley slots at all times.

Further investigation by BASI revealed that the two aileron control cable decals<sup>1</sup> on the aileron cable drum's inboard and outboard mounting brackets at WS767 and WS780 were installed incorrectly. The decal for WS767 was fitted at WS780 and vice versa. BASI also found that a similar 747 aircraft, S/N 23028, production line number 584, had the aileron cable replaced because of excessive wear, and the cable was frayed down to one remaining strand. This aircraft also had the two aileron control cable decals on the aileron cable drum's inboard and outboard mounting brackets at WS767 and WS780 fitted incorrectly and interchanged. Because of the decals' transposition, the Safety Board requested a U.S. operator to randomly inspect its 747 airplane aileron control systems for the aileron cable drum decal identification at WS767 and WS780. An inspection on November 24, 1997, of one 747-251, S/N 21707, production line number 378, revealed similar decal transposition on the right WS767 and WS780.

The BASI investigation concluded that the Brisbane incident was caused by misrouting of cables on the aileron cable drum at WS776.98 and that transposition of the aileron control cable decals on the aileron cable drum at WS767 and WS780 has the potential to cause misalignment of the aileron control cables during installation. The Safety Board is concerned that airplanes with mispositioned aileron cable installation decals may be susceptible to aileron cable failures in flight, which could jeopardize flight safety. The Safety Board believes that the Federal Aviation Administration should issue an airworthiness directive to require operators of 747s, produced before production line number 1130, to conduct a one-time inspection of the aileron control system to ensure correct routing of aileron control cables on the aileron cable drum located at WS776.98 and correct installation of aileron cable decals at WS767 and WS780 at the earliest possible inspection interval.

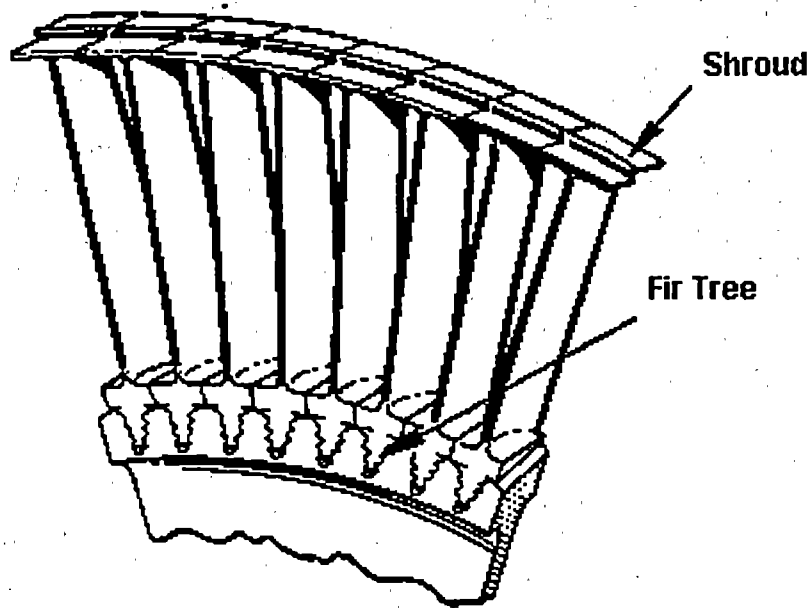
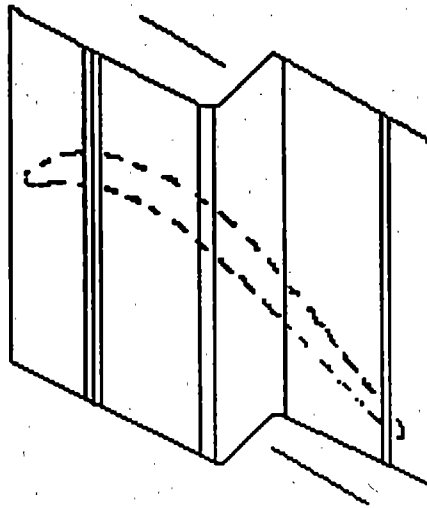
Typical Top View of Blade

origin area. Examination of the 4<sup>th</sup> stage LPT blade shroud notches<sup>3</sup> that were recovered from the exhaust case revealed evidence of extreme notch wear estimated at 0.030 to 0.050 inch in depth.

The JT8D LPT blade design incorporates a blade tip shroud for structural support and vibration dampening. The blade shrouds interlock to provide stiffness so that they function as a single ring to reduce blade flexing caused by thermal, aerodynamic and centrifugal loads. The shroud notches (contact areas) are coated with PWA 694, which is a cobalt alloy that is a hard temperature and wear resistant material, to help reduce wearing. Worn shroud notch surfaces reduce blade damping and drop the blades' resonance frequency into the engine operating range. This increases the vibratory stresses to levels that can initiate fatigue cracking.

Determine the effectiveness of inspection techniques used to measure the amount of shroud wear on installed 3<sup>rd</sup> and 4<sup>th</sup> stage low pressure turbine blades on Pratt & Whitney JT8D-200 series turbofan engines, and mandate inspection techniques determined to be most effective based on an interval derived from failure and operational data. (A-98-8)

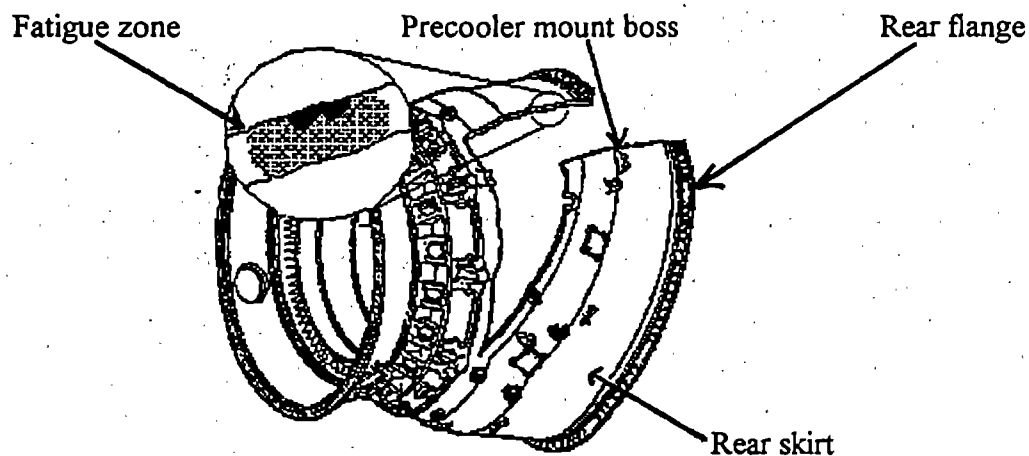
Figure 1: Ruptured diffuser case

The National Transportation Safety Board's (NTSB) examination of the engine discovered an L-shaped crack in the outer pressure wall in the rear skirt area of the diffuser case that was deflected outward exposing the bulged combustion chamber inside the engine. The crack extended fore and aft approximately 18 inches from the diffuser case's rear flange at the 11 o'clock<sup>1</sup> position. The crack turned 90° and extended circumferentially around approximately 120° of the case's circumference, in the counterclockwise direction. The crack passed adjacent to a 3-inch long, dog bone-shaped embossment (boss), located about 10 inches forward of the rear flange at the 11 o'clock position. The boss was the attachment point for the upper most mount bracket of the engine's 116-pound precooler.<sup>2</sup>

A section of the diffuser case rear skirt (see figure 1) was examined at the Safety Board's materials laboratory in Washington, D.C. Examination of the fracture surface, approximately 10 ½ inches from the rear flange, adjacent to the upper precooler mount boss, revealed a 5-inch long discolored high cycle fatigue<sup>3</sup> (HCF) zone with about 90,000 striations. The fatigue initiated at a crack that looked like two thumbnail-shaped, gray-colored areas, which were approximately 0.040-inch wide by 0.010-inch deep. High levels of delta phase precipitate<sup>4</sup> were discovered in the thumbnail-shaped origin areas. Individual 0.0005 to 0.0008-inch deep toolmarks or scratches were found on the outer case wall extending the length of the origin area. Numerous additional toolmarks were found on the exterior surface of the rear skirt. The toolmarks were formed when the exterior surface of the case was machined (blended) during manufacture. The diffuser case had accumulated 9,342 total flight cycles<sup>5</sup> since new.

A metallurgical analysis of the fracture surface indicated that the thumbnail-shaped cracks had initiated at the base of the toolmarks because of a combination of high residual stresses and low-cycle fatigue<sup>6</sup> (LCF). The crack then propagated in HCF, as evidenced by the very small striation spacing found in the majority of the 5-inch long fatigue zone, after which the crack progressed to failure in tensile overload.

Require a one-time visual inspection of the diffuser case rear skirt on Pratt & Whitney JT9D-7Q engines to locate scratches and tool marks when the diffuser case is next at the piece-part level, and blend repair as required to prevent tool marks and scratches from becoming crack initiation sites. (A-98-25)

Require modification of the engine bracket that attaches to the diffuser case's precooler upper mount boss on the Pratt & Whitney JT9D-7Q installation to increase clearance between the bracket and support link to reduce vibration and to reduce wear. (A-98-26)
